Reference: Company Introduction for Ultraviolet and Water Systems Audit Results

Reference: Ultraviolet and Water Systems Audit Results

The purpose of this audit started on Pepsi's desire to evaluate their ultraviolet (UV) disinfection systems. We were also asked to evaluate their reverse Osmosis (RO) systems.

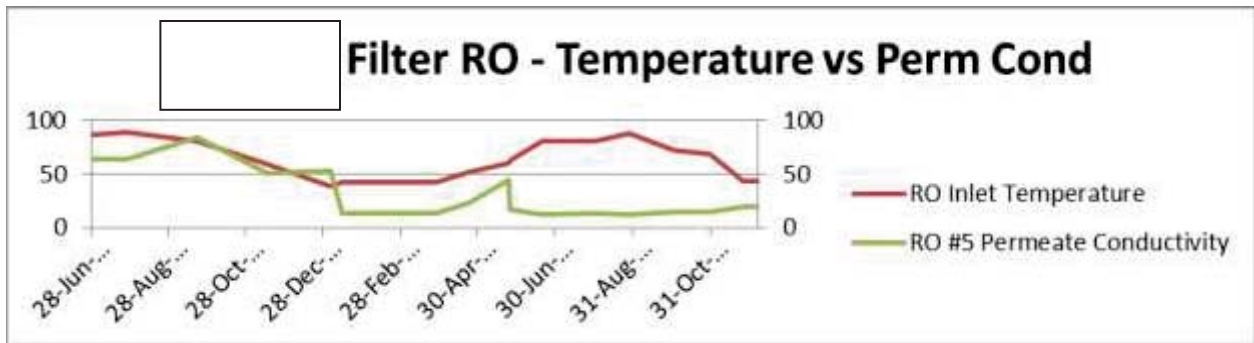
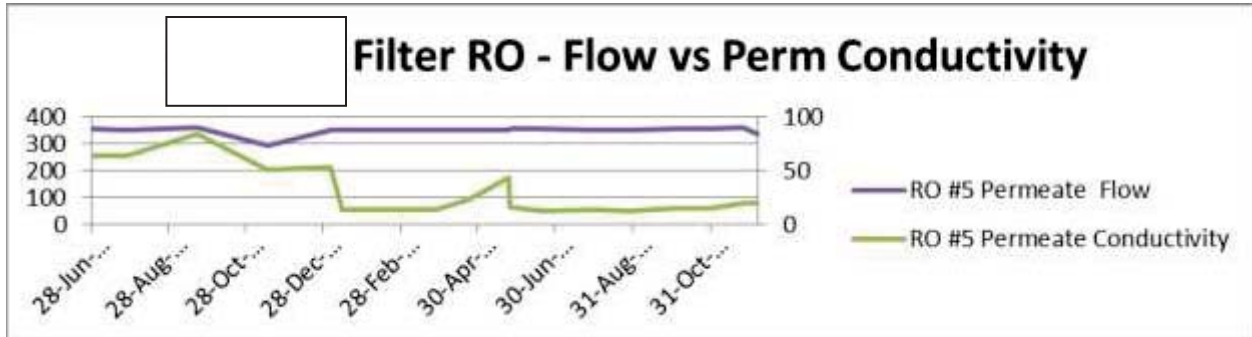
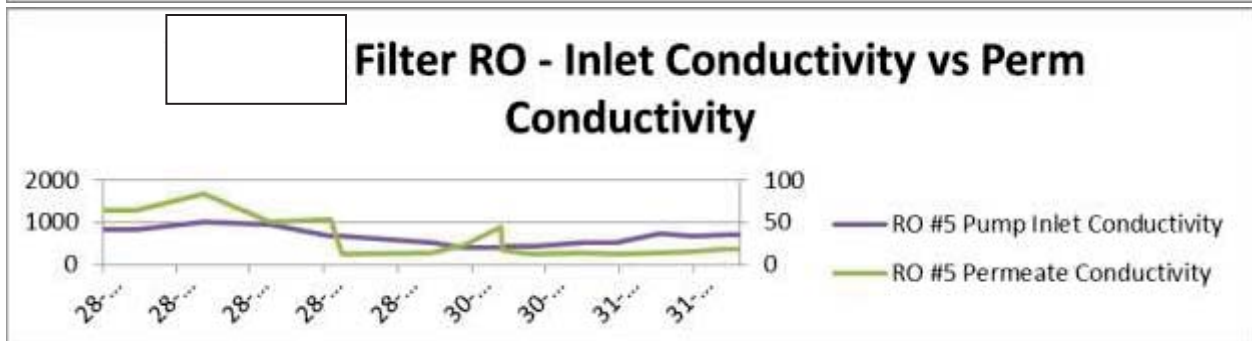
FILTER RO SYSTEM

I am assuming an operator adjusted the valves on January 13, 2014 to make more water because the permeate quality increased and the pressure increased. This can be dangerous because when the water's temperature goes down the production rate decreases. By adjusting the valves to put more pressure on the system leads to fouling. It does not appear to be caused by a VFD on the motor because the pressure is not increasing proportional to the temperature change.

The membrane shows some fouling over the year because the flow rates and pressures do not match similar temperatures from the previous year. This may also be due to not adjusting the valves over the change in seasons.

The membrane were either replaced or cleaned on January 13, 2013 and May 13, 2013. Membrane should last 3 to 5 years.

- When the water temperature increases into Spring and especially Summer seasons re-adjust the valves back. DO NOT keep making higher volumes of water because the pores will open and the RO system will begin making more water, if no changes are made the membrane will foul relatively quickly leading to downtime and expense.
- The data ended in December 2013. The conductivity and pressure is starting to rise and the flow is starting to decrease. Another cleaning may need to be scheduled.

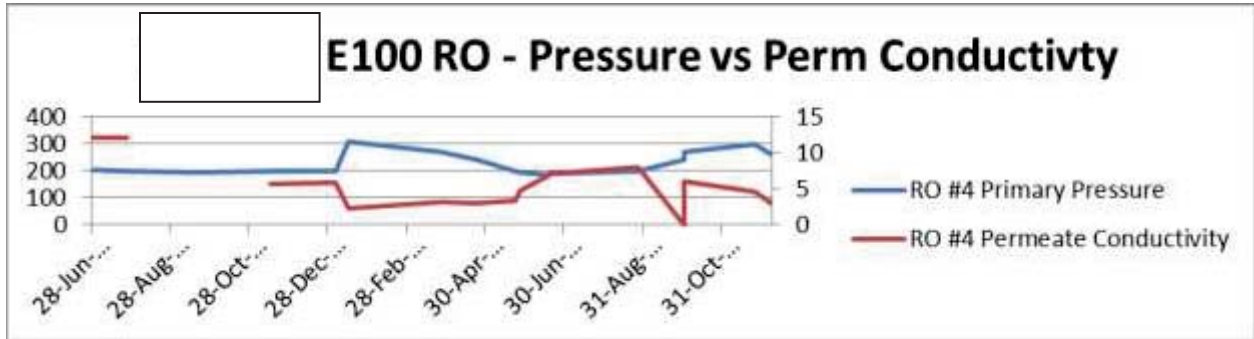
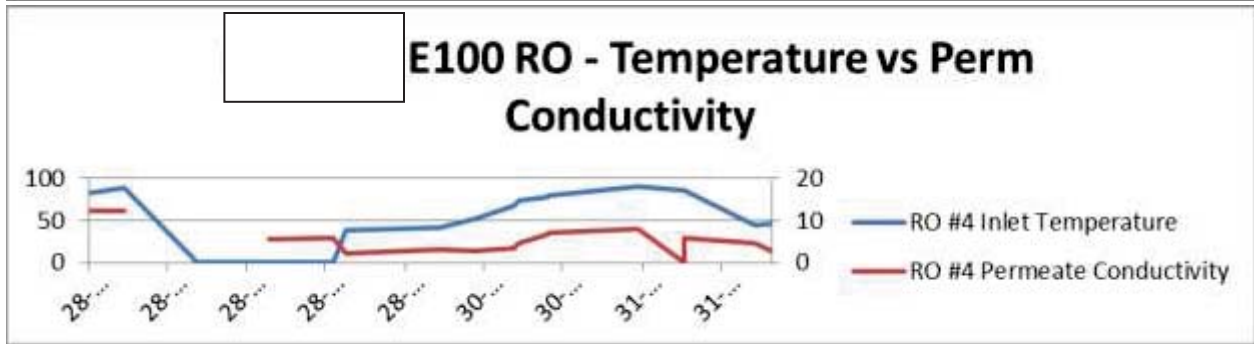
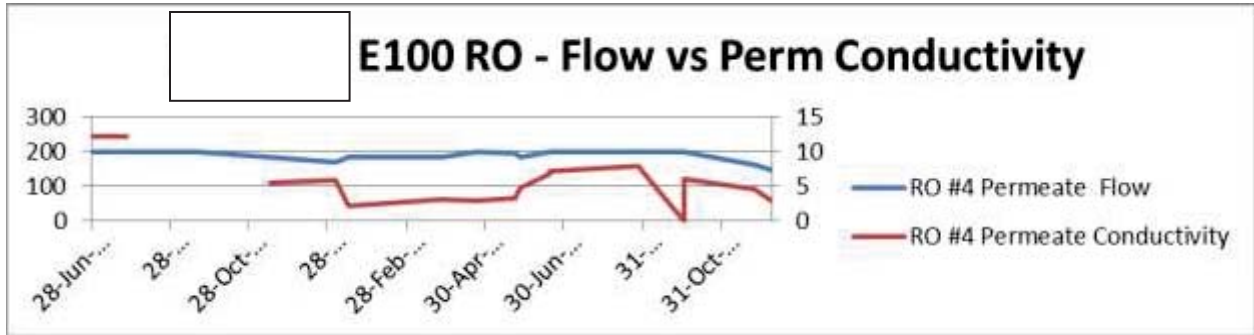
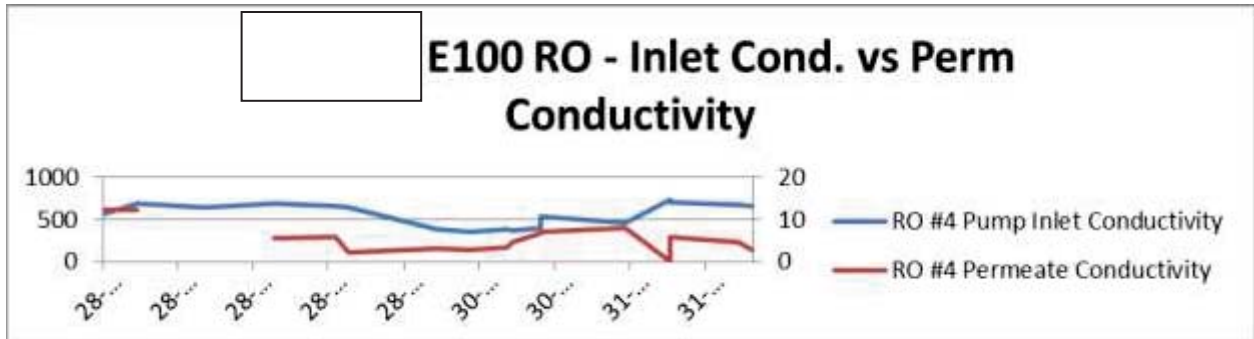
RO SYSTEM

It appears something happened around January, 13, 2013. The inlet conductivity decreased which should have made the permeate quality increase but the permeate quality decreased.

Another phenomenon happened around May 23rd, 2013. It appears perhaps the pressure valves were adjusted. Now the pressure has steadily increased and the flow is decreasing. This shows signs that the membrane are fouling.

- Check the antiscalant dosing. Perhaps it needs to be increased.
- Check the UV
- Make sure the prefilters are installed correctly
- Check to make sure there is an appropriate pressure drop across the sand per-filters

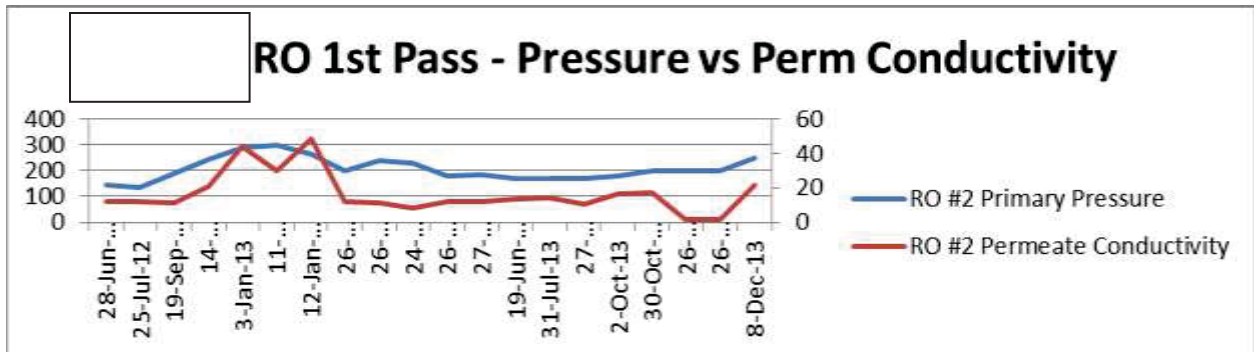
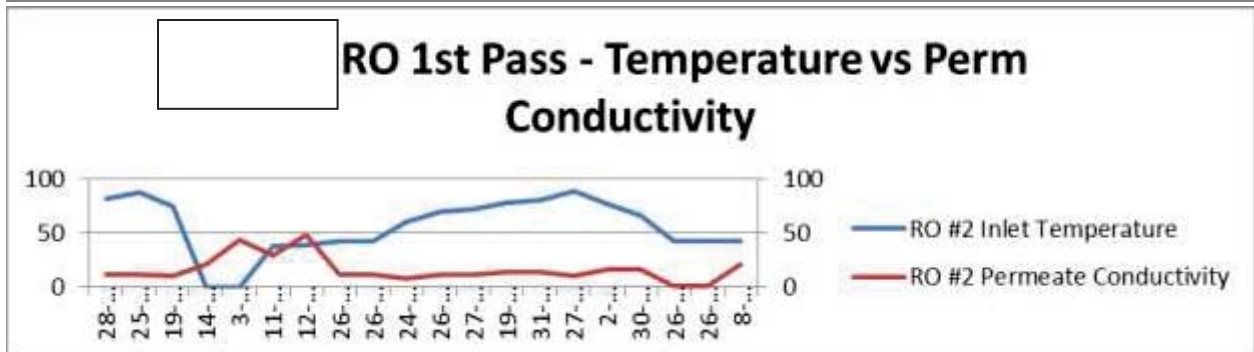
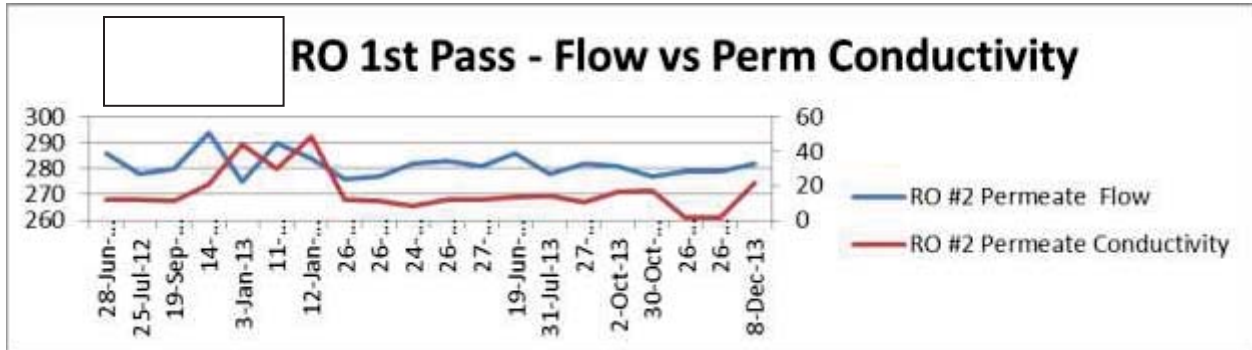
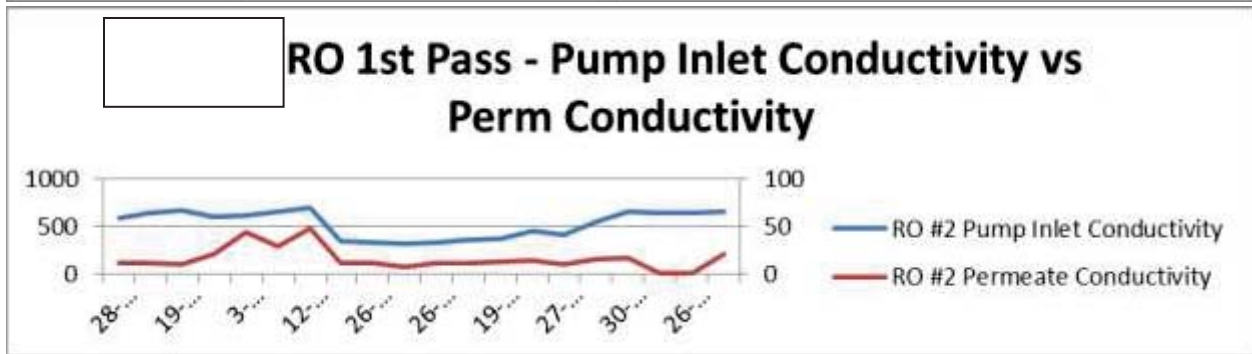
First Pass:

There are some interesting readings during the winter of 1013 so I will begin analyzing around March 13, 2013. All signals look pretty good. I am assuming the membrane were exchanged or perhaps a cleaned around November 13, 2013. However the conductivity and pressure appears to be increasing at an alarming rate.

- The conductivity and pressure appears to be increasing starting November 2013. This shows the membrane are fouling at a high rate.
- Check the antiscalant dosing. Perhaps it needs to be increased.
- Check the UV
- Make sure the prefilters are installed correctly
- Check to make sure there is an appropriate pressure drop across the sand per-filters

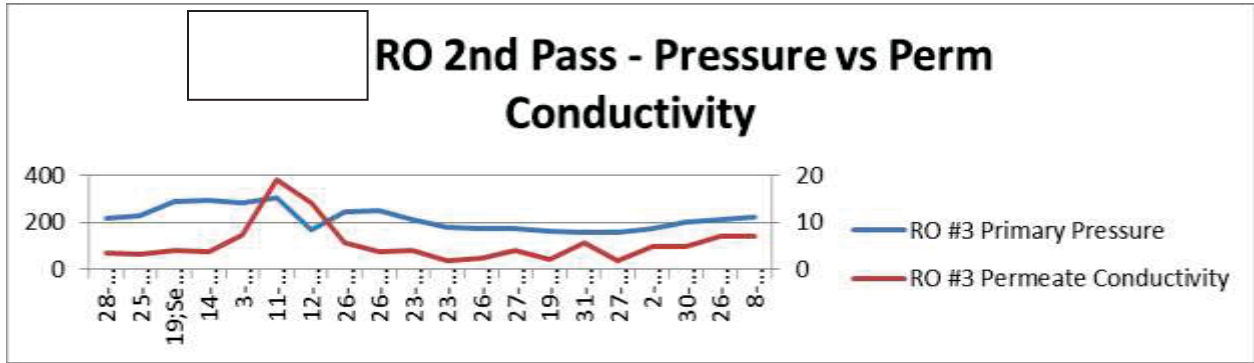
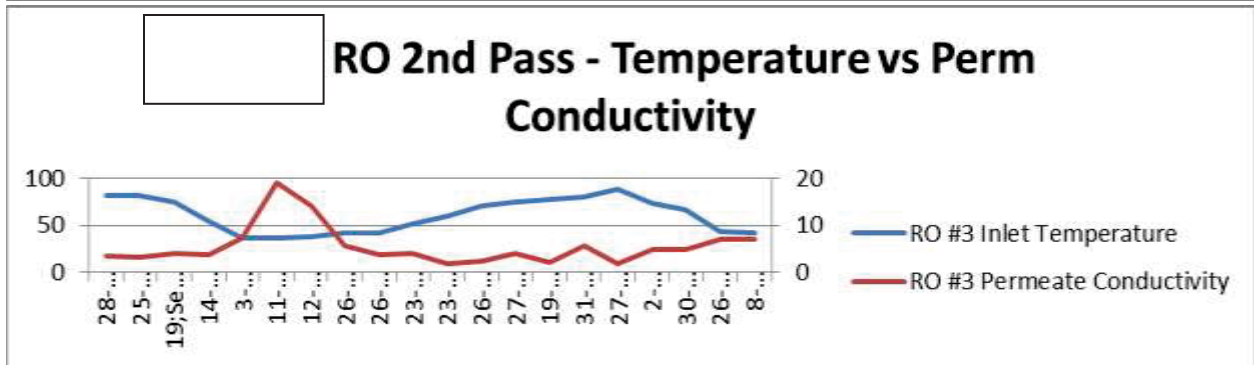
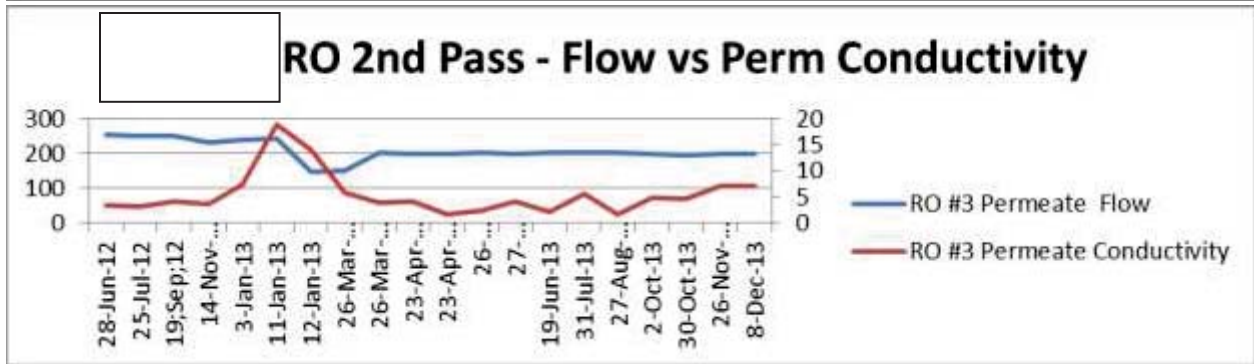
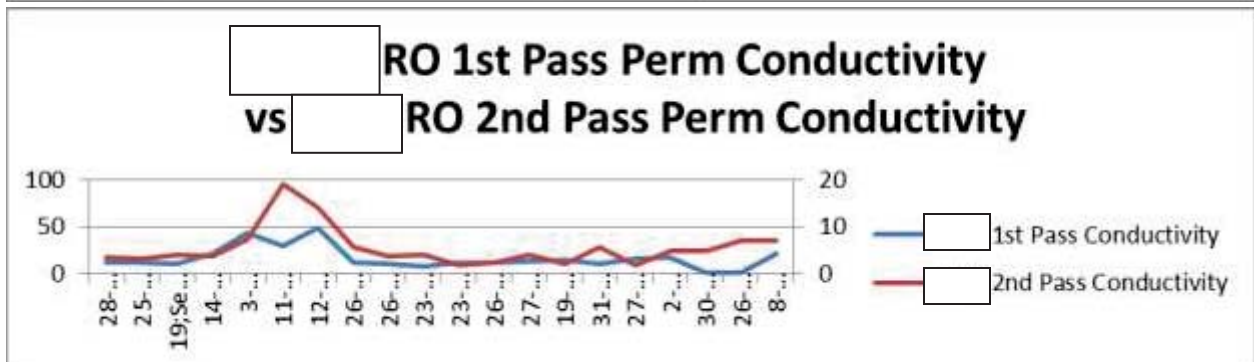
Second Pass:

It is somewhat uncommon for the second pass to foul. The permeate quality is semi-closely following the inlet water quality which is a good sign. This system appears to be on a VFD. As the temperature is decreasing the pressure is increasing to keep the permeate flow rate constant.

The permeate quality is decreasing. So far I believe this is in proportion to the first pass' permeate quality.

- I would consider leaving this pass alone and concentrate on the first pass.
