Reference: Quarterly Engineering Support Analysis

The data received was from when the new membrane were installed in March 2015 to first part of June 2015.

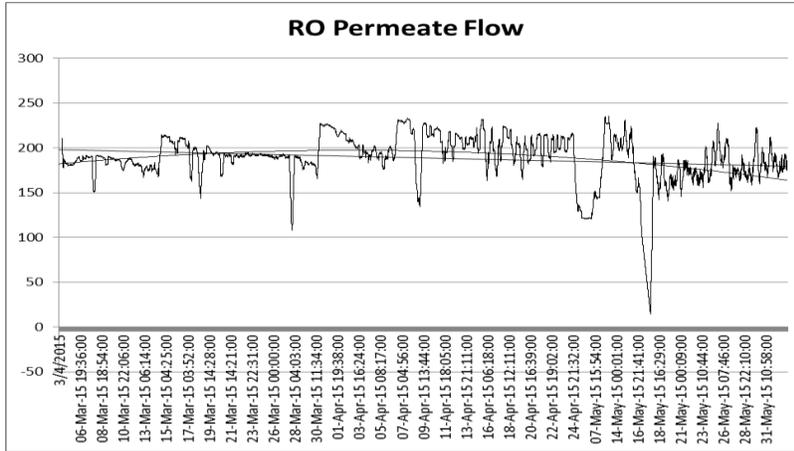
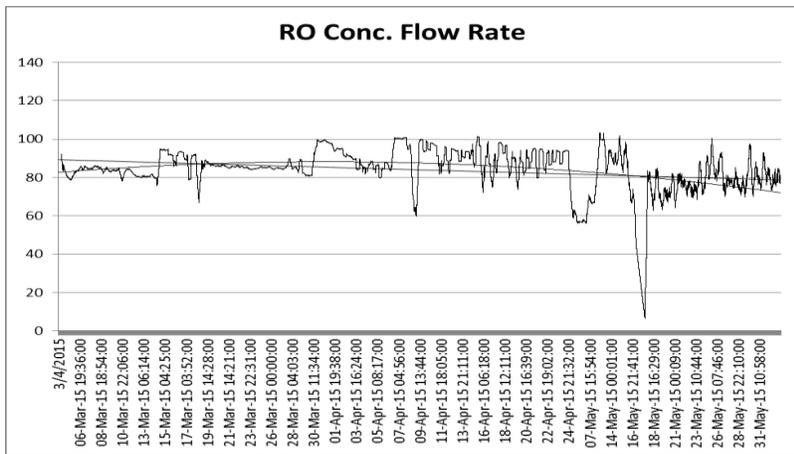
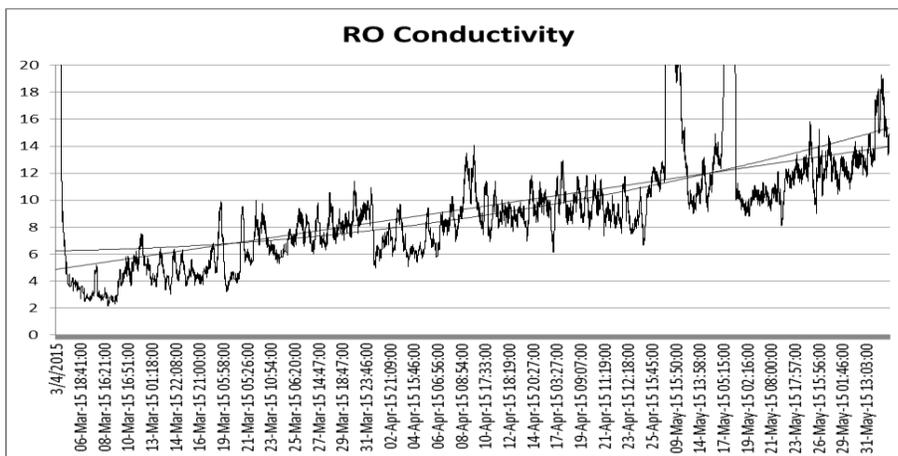
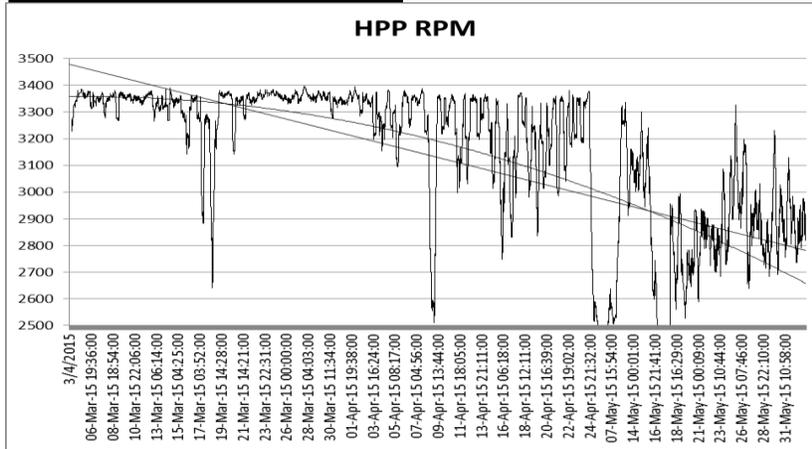
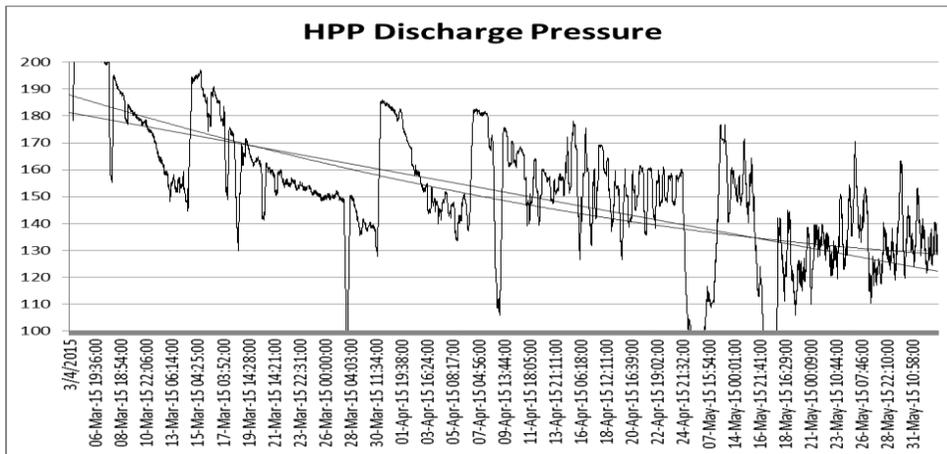
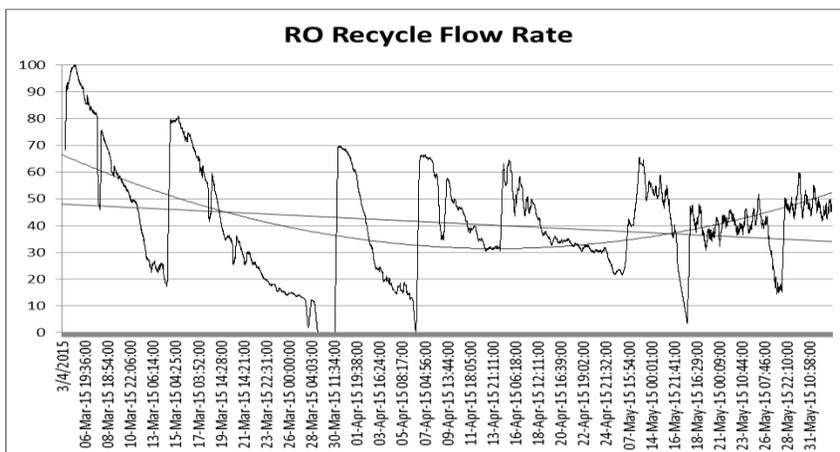
**GRAPHS**

- The RO inlet pressure has steadily decreased from ~180 PSIG to 130 PSIG.
- The flow rates increased around the 1<sup>st</sup> of May and held steady until the ~18<sup>th</sup> of May where they decreased and are holding steady.
- The RO permeate conductivity is increasing from around ~4 to ~13 at the end of May.
- % reclaim is stable at ~70%
- RO permeate pressure is stable at ~24 PSIG
- The system's HPP's pressure seems to repeatedly steadily trend downward for ~7 days at a time and then jumps back up and the HPP's RPM does not follow that trend pattern.

The pressure is decreasing, the flow rate is increasing, and the permeate quality is decreasing. Things that could cause this are:

- Increase in water temperature.
- The membrane's pores are getting eaten which is normally caused by Chlorine or Chloramines.

The autopsy reports from the last membrane autopsy noted Bromination which is caused by Chlorine, Chloramines, or Bromine that is in the feed water.

My recommendation is to check the concentrate for Total Chlorine. If none is found then check for Bromine. Your chemical supplier should know if there is Bromine in the feed water. Chlorine, Chloramines, and Bromine should be easily removed with your Sodium Metabisulfite chemical injection.
